Manhole Inspection Summary

Manhole # S39W__011MH

Insp Date: **2/27/08 11:06 AM**

Location Address: **1840 webster st..**

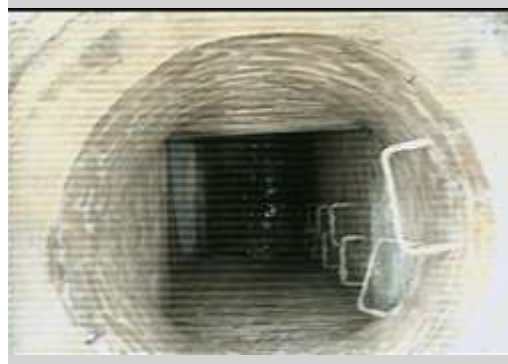
Top View

Steps Count: **10** Missing: **1** ☒ **Corroded**

missing step

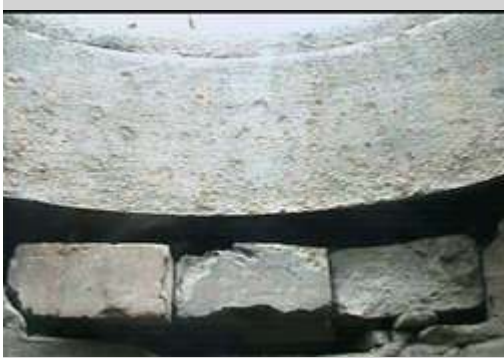
Defect 1

Condition: ☐ Sound ☐ Cracked ☐ Root Intrusion ☒ **Loose Brick** ☐ Deteriorated

loose brick corbel

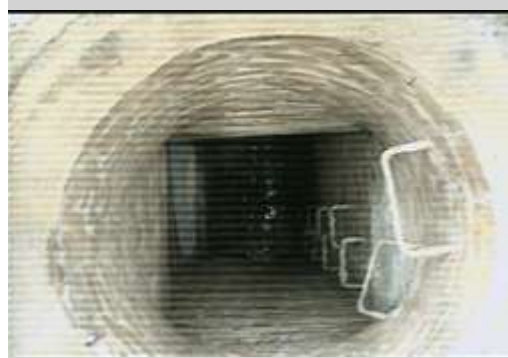
Defect 2

corroded and missing step

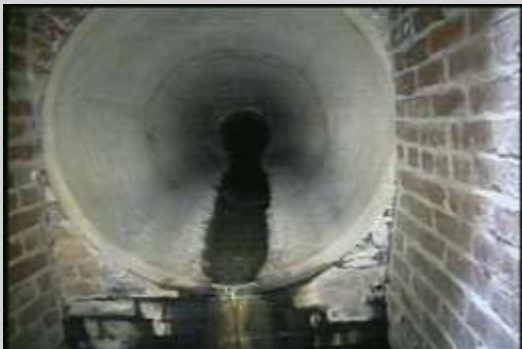
6 O'Clock Inflow

splash

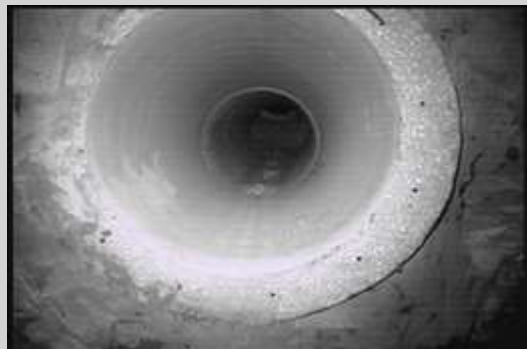
9 O'Clock Inflow

splash
